Contract #: 04-0120F4Cty: SF/ALA Rte: 80 PM: 13.2/13.9File #: 69.28**WELDING INSPECTION REPORT****Resident Engineer:**Pursell, Gary**Address:** 333 Burma Road**City:** Oakland, CA 94607**Report No:** WIR-002884**Date Inspected:** 03-Jun-2008**Project Name:** SAS Superstructure**OSM Arrival Time:** 2300**Prime Contractor:** American Bridge/Fluor Enterprises, a JV**OSM Departure Time:** 800**Contractor:** Zhenhua Port Machinery Company, Ltd (ZPMC), Changxing Island **Location:** Shanghai, China**CWI Name:** Xu Le Feng**CWI Present:** Yes No**Inspected CWI report:** Yes No N/A**Rod Oven in Use:** Yes No N/A**Electrode to specification:** Yes No N/A**Weld Procedures Followed:** Yes No N/A**Qualified Welders:** Yes No N/A**Verified Joint Fit-up:** Yes No N/A**Approved Drawings:** Yes No N/A**Approved WPS:** Yes No N/A**Delayed / Cancelled:** Yes No N/A**Bridge No:** 34-0006**Component:** Tower**Summary of Items Observed:**

New Tower Shop Bay 1:

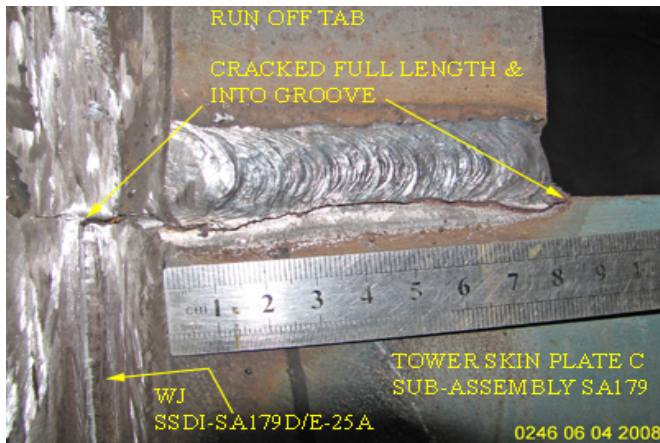
The QA Inspector randomly observed ZPMC welder Chen Hongxia ID Number 040460, utilizing the Submerged Arc Welding (SAW) Process in the 1G Position (Flat Groove) with ZPMC Weld Procedure Specification (WPS) WPS-B-T-2221-B-U3c-S, to weld the fill pass in Weld Joint (WJ) SSD1-SA179B/E-11A(CJP) on Tower Skin Plate C Sub-Assembly SA179(S). The QA Inspector randomly observed ZPMC CWI Xu Le Feng monitoring weld parameters. The QA Inspector also randomly monitored weld parameters and recorded them as follows: 678 amps, 32.6 volts with a travel speed of 563 millimeters (mm) per minute. The weld parameters appeared to comply with contract requirements. The attached photograph provides additional detail.

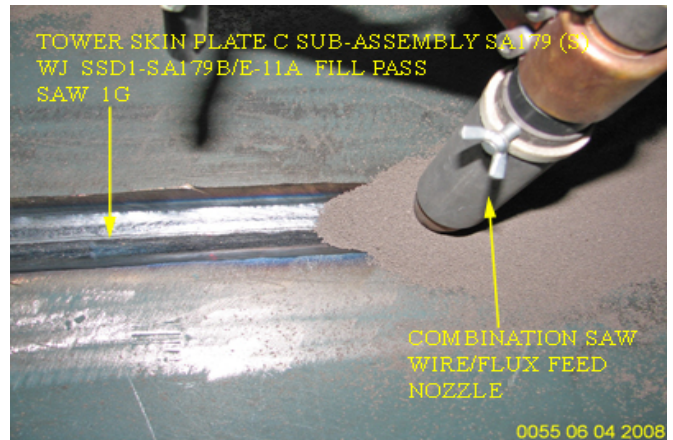
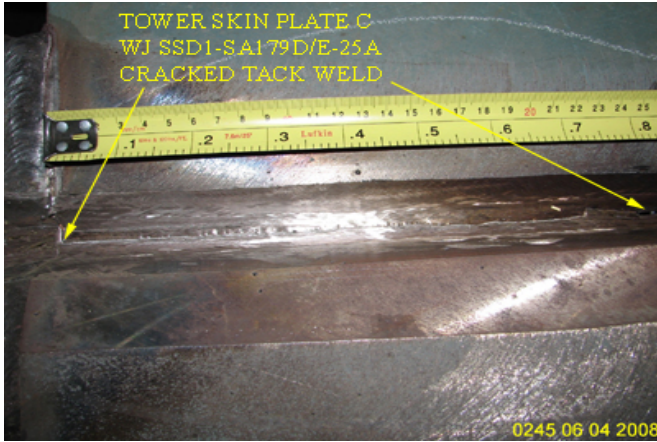
The QA Inspector randomly observed ZPMC welder Chen Hongxia ID Number 040460, setting up to utilize the SAW Process in the 1G Position (Flat Groove) with ZPMC WPS WPS-B-T-2221-B-U3c-S, to weld the root pass in WJ SSD1-SA179D/E-14A(CJP), 12(PJP) and 25A(CJP). The QA Inspector randomly observed ZPMC CWI Xu Le Feng visually examining the tack welds in the above WJ's and marking up several that had cracked while the pre-heat was being applied. The QA Inspector randomly observed Mr. Xu mark up the 1 tack in WJ 14A and the 1 tack weld in 25A along with 8 of the 32 tack welds in WJ 12. The QA Inspector randomly observed an additional cracked tack weld in WJ 12 and a cracked weld in the run off tab at the end of WJ 25A, which had propagated into the tack weld of WJ 25A. Mr. Xu informed the QA Inspector that no welding would be performed and that ZPMC QC would perform 100% Magnetic Particle (MT) Examination of all of the tack welds in the 3 WJ's, to be followed up by repairs. Mr. Xu informed the QA Inspector that this would be done during the day shift on 06-04-08. The attached photographs provide additional detail.
